Maryland Historical Trust
State Historic Sites Inventory Form

Survey No. B-4366

historic 700 North Howard Street
and/or common House of Burgess Antiques and Interior

street & number 700 N. Howard Street not for publication
city, town Baltimore Seventh
state Maryland Baltimore
county

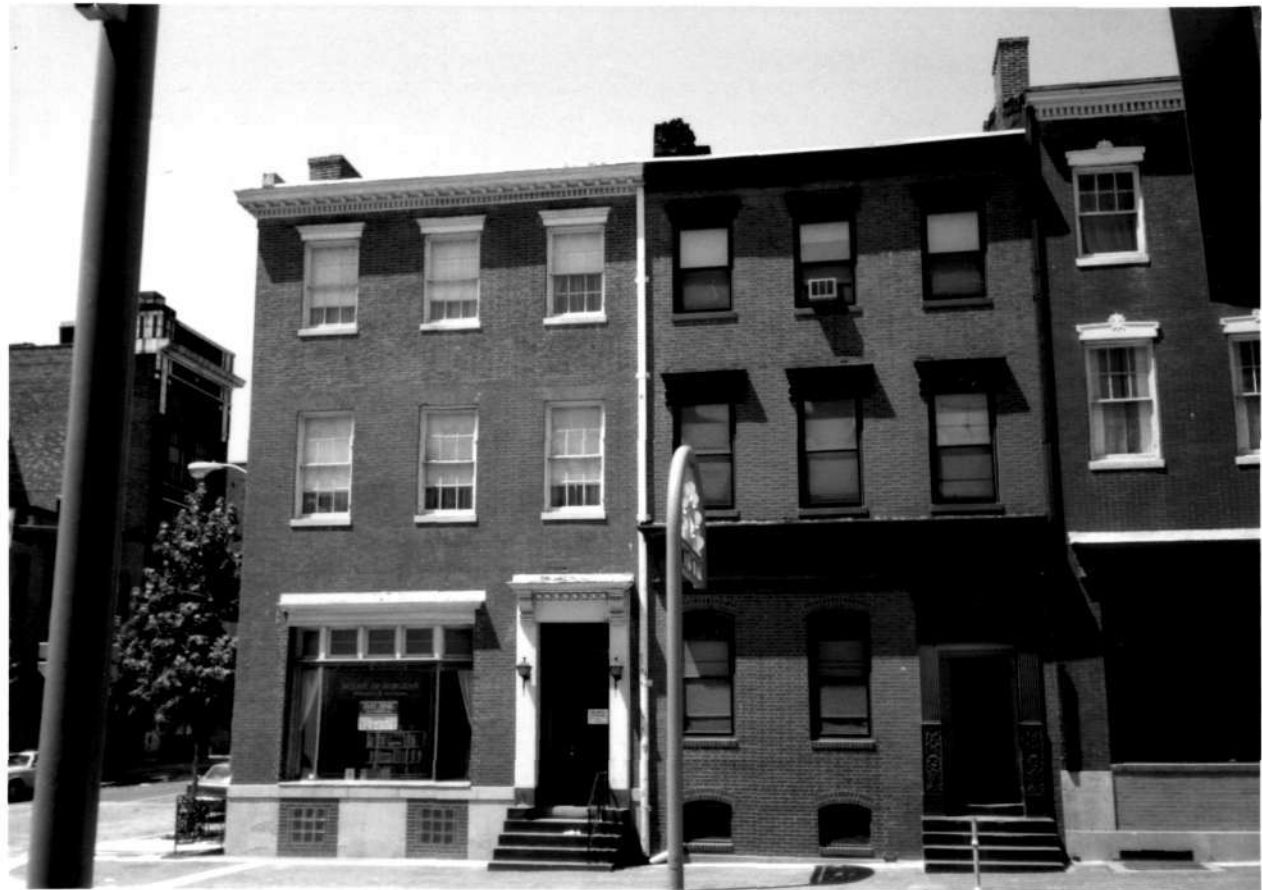
1/4

Facade, east elevation, plus adjoining
partywall building

The main facade faces east on N. Howard Street. It has been altered on the first story to accommodate a late-nineteenth-century commercial shop front. The first story is slightly raised above grade, with a cellar below. The brick foundation has been covered with a granite facing and the cellar windows have been infilled with glass block with brick surrounds.

Five brownstone steps, with a 20th-century handrail, lead to the entrance in the third (northern) bay. The front door is recessed behind a vestibule that presently has an iron gate. The vestibule entrance has an Italianate bracketed cornice over the stoop. Within the vestibule are two sets of steps -- two steps to the west leading to the original door and two steps to the south leading to a later door cut in when the commercial and residential floors were distinguished. The original doorway is flanked by fluted wooden columns supporting a heavily painted, flat entablature consisting of bands and fillets. The three raised panel double doors are replacements. The doorway is capped by a fan shaped transom with ribbed came in a petal motif. The ceiling of the vestibule is arched and embellished with a raised panel that follows the curve. The second doorway has a much simpler architrave of circa 1860 three-grooved jambs and a plain lintel. The door itself is 20th century, with the top half a glazed panel.

The first and second bays of the first floor have been altered by a large, three-sided display window that has been cut into the brick. The window does not project beyond the plane of the facade since the angled side pieces are narrow and are fixed from the inside (not outside) plane of the wall. The three-sided window is further divided into upper and lower panes. The upper portion is a series of five squared, fixed transoms (three in the middle section and two for each angled side window). The lower portion consists of three large single panes of glass with the larger pane in the middle and the narrower panes on the flanking sides. The panes are joined by 20th-century metal mutins. The window lintel has a an ogee, a fillet, band, and fillet base. The cornice appears to antedate the present window.

The second and third stories each have three evenly spaced 6/6 sash windows with stone sills and shutter pintels. The second story has brick splayed jack arches. The third story has wood lintels with an ogee and fillets over a flat band profile. The third-story windows are shorter than those on the second story.

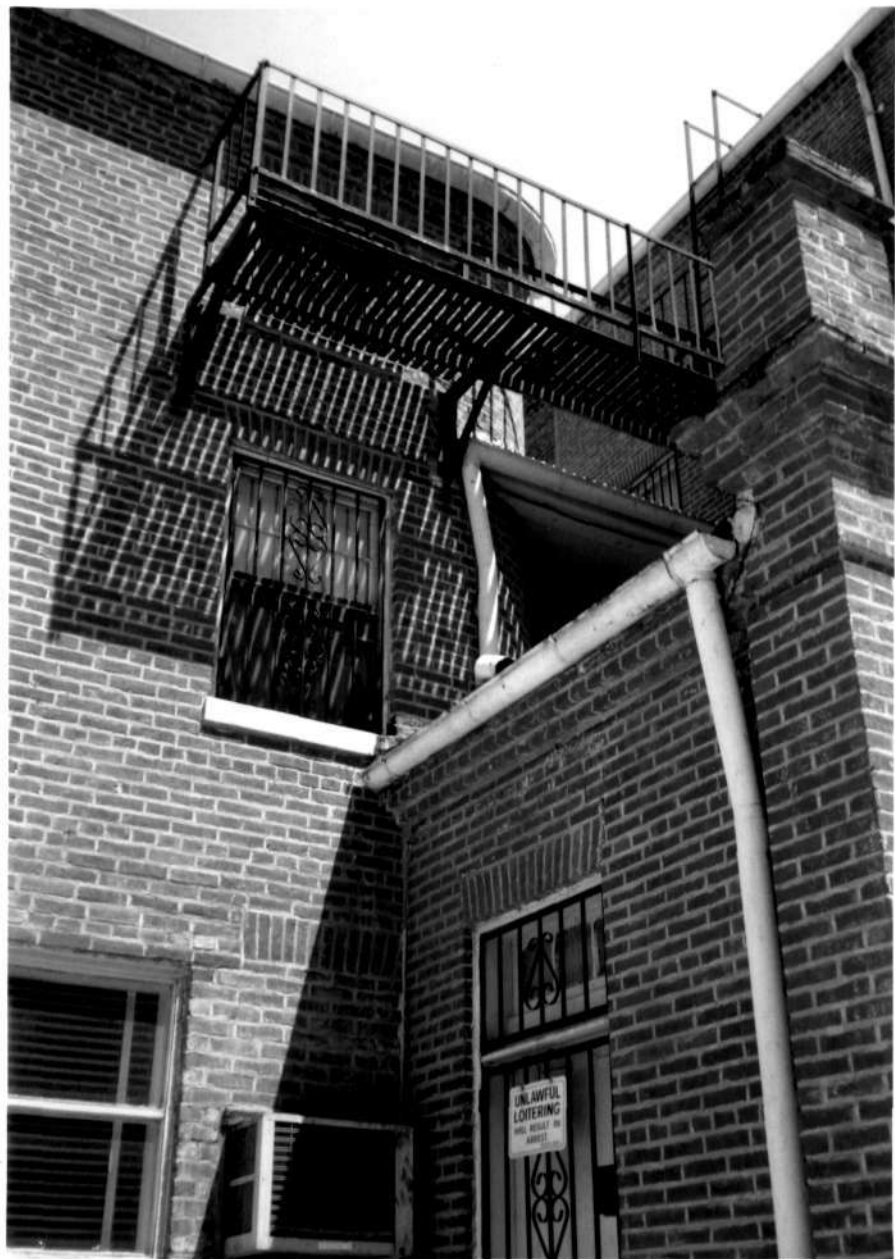
2/4

Detail, juncture of back building
to main house

Attached to the back of the main house is a one-story addition of later 19th century date. The brick is laid in a variable common bond. The two 6/6 sash windows have sloping Italianate lintels with peaked center profile. Brick pilasters at the corner of the building support a brick entablature that includes a molded brick cornice. A solid brick wall forms a continuous balustrade along the roof. Blind arches provide a decorative pattern in the balustrade wall. The back building is further attached to a 20th-century, two-story building known as 300 W. Monument Street but is not described here.

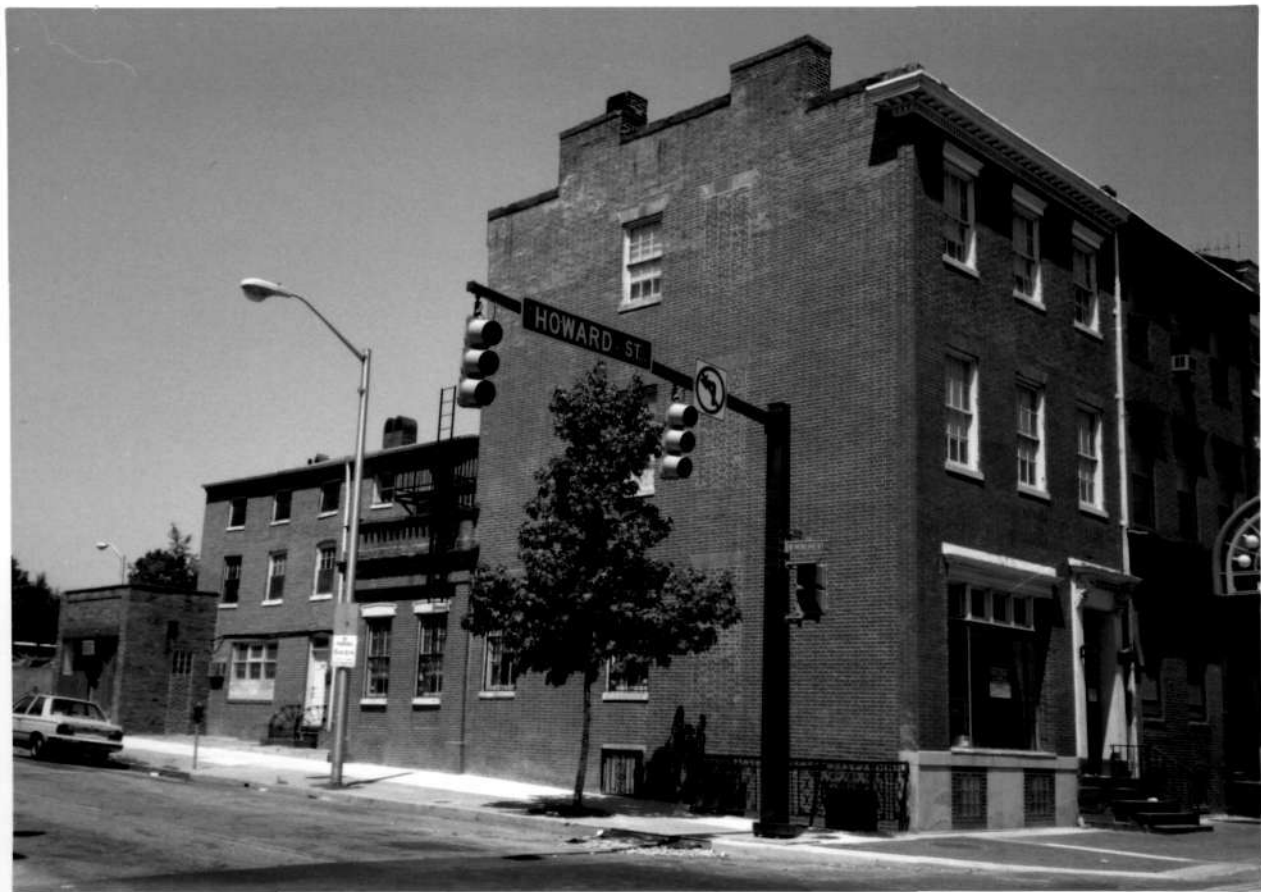
3/4

SE elevation

The south facade faces Monument Street. The four-bay long building includes the original main house and an attached back building of later date.

The main house is two-bays deep and laid in flemish bond. Each story has two evenly spaced 6/6 sash windows with splayed jack lintels. The windows are positioned in between two recessed chimneys with stacks that rise from the roof. As with the east facade windows, they also become increasingly shorter on each upper floor. The windows to the west have been bricked up. A new window on the first floor has been cut into the far west corner, as has one cellar window below. A cellar door cut into the east corner of the wall has an original jack arches. The Howard Street facade cornice wraps around the corner and terminates. There is no further cornice on this wall.

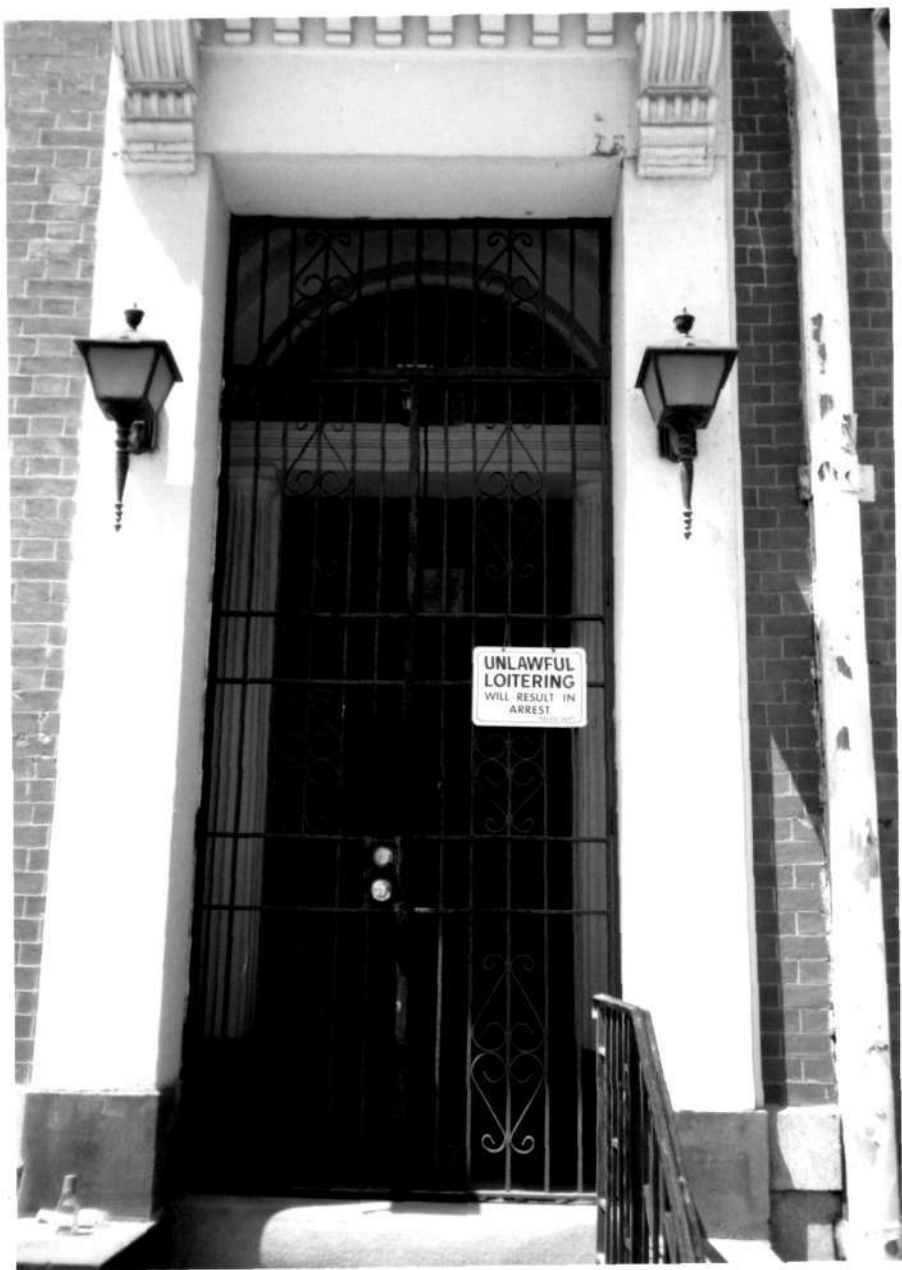
4/4

Facade detail
